## Dear UP Partners, Dear UP pilots,

### ***The following models and gliders are affected by this notice:***

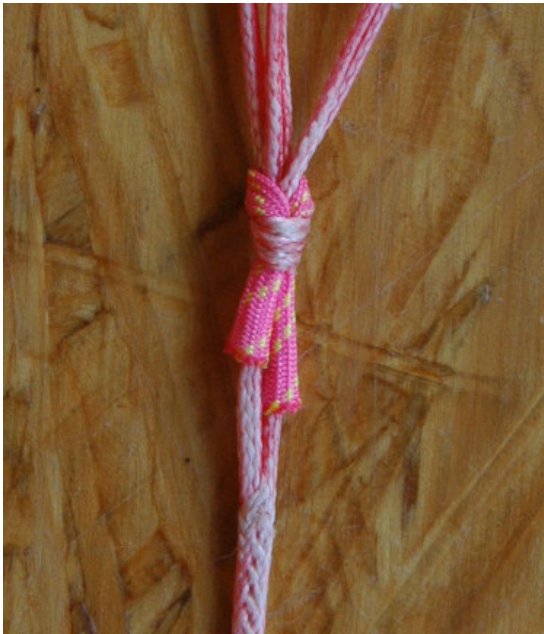
Dyneema with Line sleeves=Rev. 1

As you will see from above we have already changed the production process for the wings affected, meaning that wings manufactured after New Year 2008/2009 already have the new Aramide line layout. In spite of this, date of purchase is NOT a reliable way to tell if a particular wing is a Revision one or Revision two model – it could have been sitting in storage either at UP or with a distributor. The best way to identify the affected wings is by using the serial number (see above), or, failing that, by checking if the so-called 'line sleeves' used on the Revision one wings – this little stocking (protecting the lines right at the bifurcations) is NOT used on Revision two/Aramide wings.

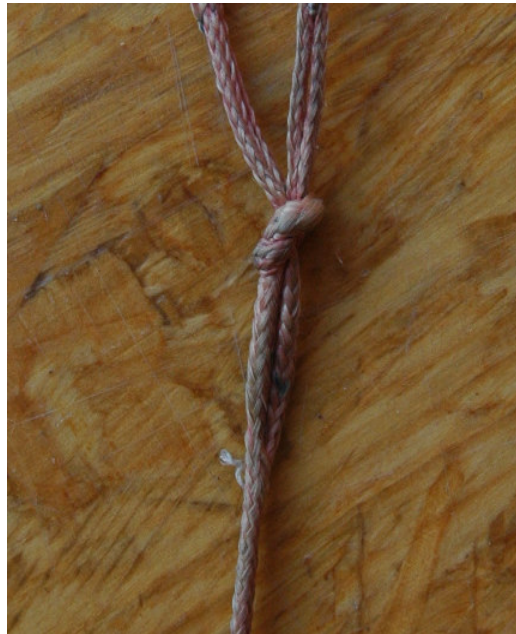
Aramide with no Line sleeves=Rev. 2
